House plan analysis Hallum-Hellema (Friesland)

Postma, D. (2020). *House plan analysis Hallum-Hellema (Friesland): A three-dimensional reconsideration of the early medieval turf buildings*. (57 ed.) (Grondsporen; No. 57). Groninger Instituut voor Archeologie, Rijksuniversiteit Groningen.

A three-dimensional reconsideration of the early medieval turf buildings

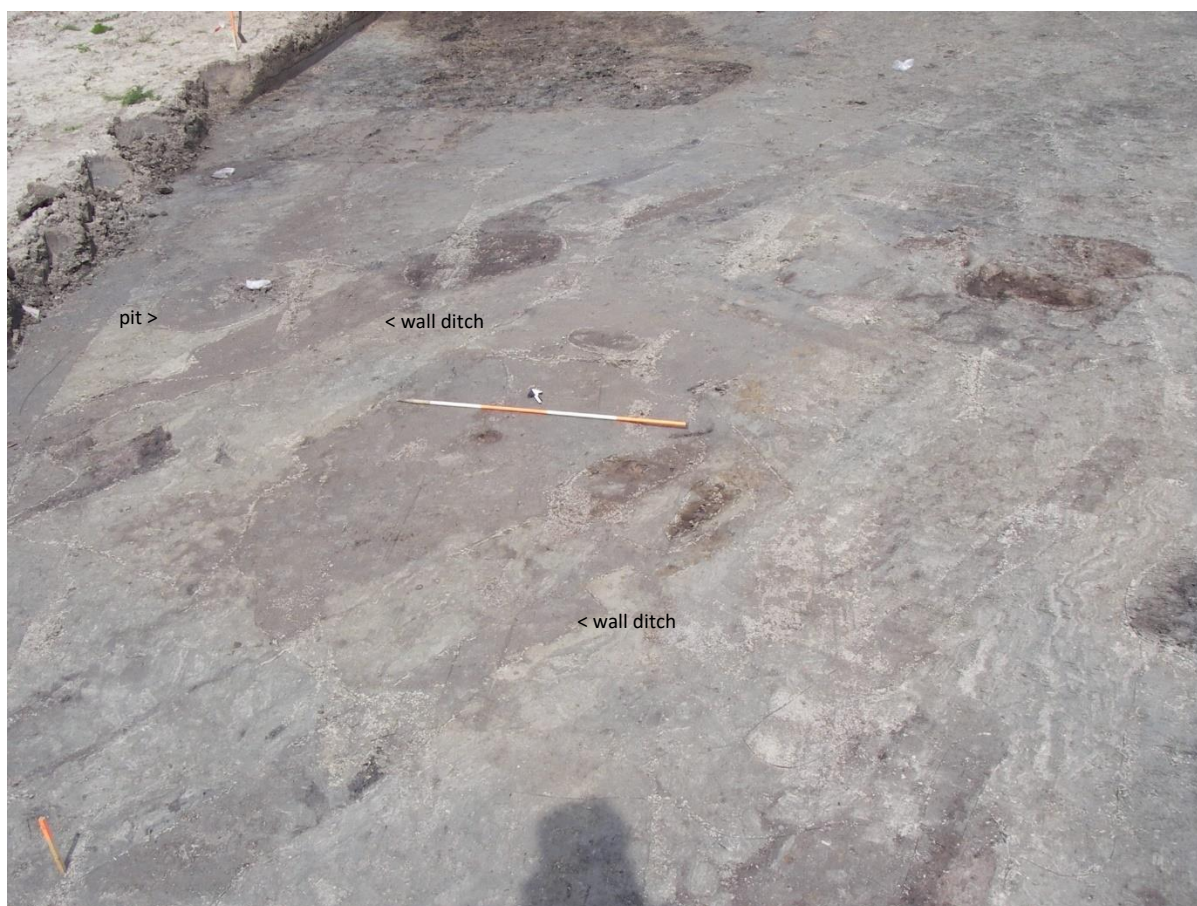
Fig. STR20-1. Trench 2, level 1, showing opposing wall ditches on either side of a distinct but unrecorded rectangular building plan.

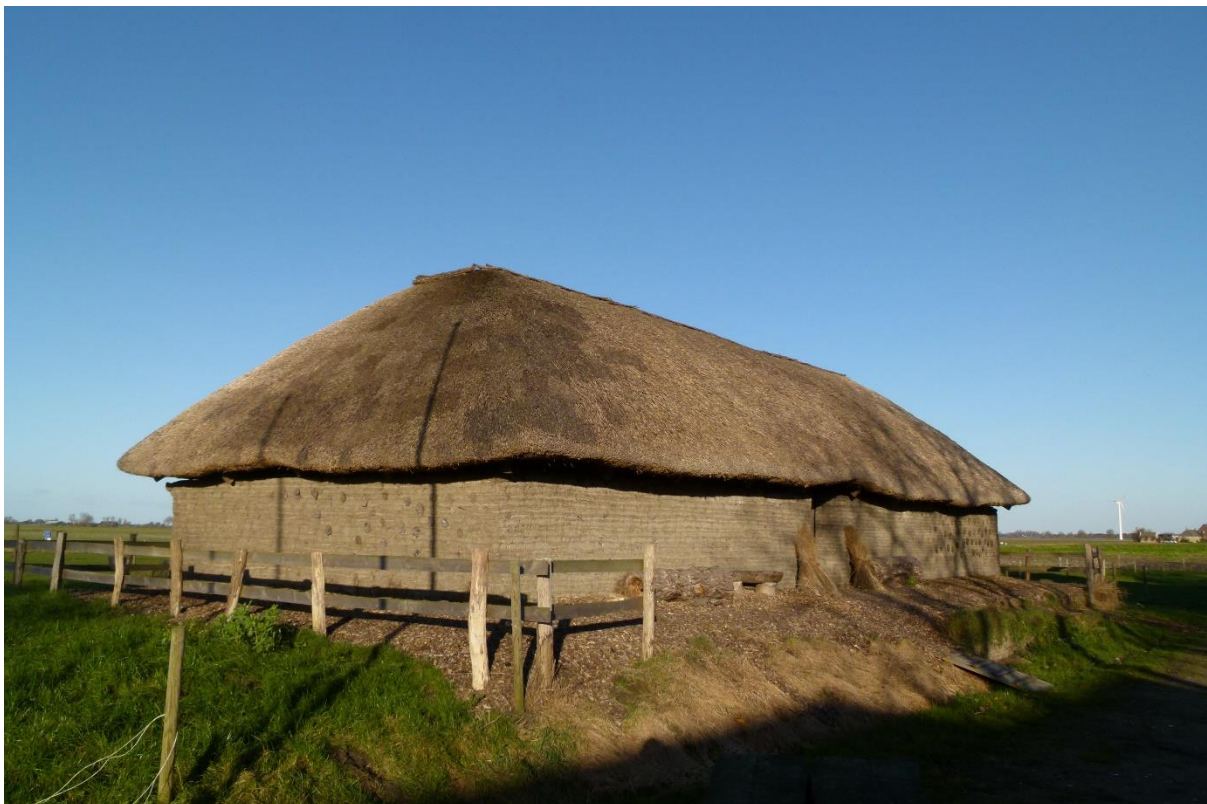
Fig. 7. Reconstructed turf byre with work area in Firdgum, Friesland.

Regarding their use, it seems evident from the presented ground plans that buildings of the Leens A type were indeed used as byres. These were initially open-planned in the Migration and early Merovingian period (cf. structures 2 and 6), but were equipped with loft-supporting interior posts as soon as the need for additional storage capacity arose (cf. structures 5, 7 and 13). As previously stated, these byres were 4-4.5 m wide, lengths in Hallum being in the region of 12.8-16 m and any interior posts rarely extending into the apparent work area in the higher end of the building. Exactly such a building has been reconstructed in Firdgum (4.5 x 15 m internally; Postma, 2015).
